AIRCRAFT INCIDENT REPORT

BOEING 747, N732PA

RENTON AIRPORT

DECEMBER 13, 1969

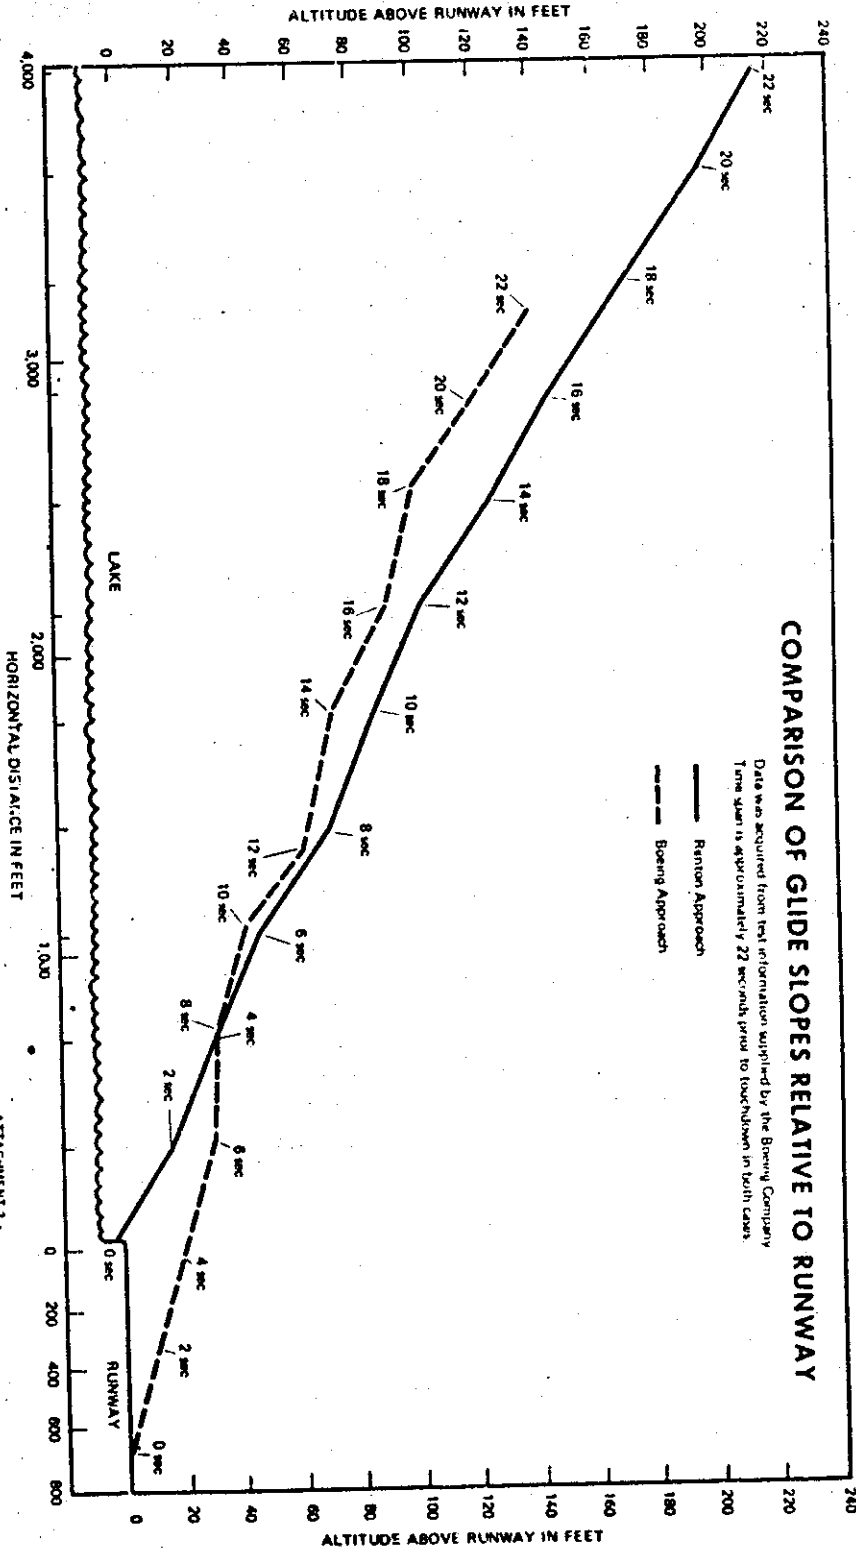
COMPARISON OF GLIDE SLOPES RELATIVE TO RUNWAY

Comparison of the flight profiles from the test instrumentation data indicated that during the last 22 seconds prior to ground contact, the rate of descent was initially 700 feet per minute for the incident, decaying to 400 feet per minute for the last 4 seconds. The rates of descent for the same periods for the Boeing Field landing, typical landing, and autoland were 550 to 300, 750 to 375, and 600 to 450 feet per minute, respectively. The altitudes, 22 seconds prior to ground contact, were 235 feet for the incident landing, 140 feet for the Boeing Field landing, 235 feet for the typical landing, and 200 feet for the autoland.

Data was acquired from test information supplied by the Boeing Company
 Time shown is approximately 22 seconds prior to touchdown in both cases
